Pacific Community Park Pool Audit Report

December 6, 2019

RE: City of Pacific, Missouri – Pacific Community Park Pool

The City of Pacific, Missouri commissioned Westport Pools, Inc. to provide an assessment of the Pacific Community Park aquatic facility. The purpose of the project was to identify existing aquatic conditions and provide key stakeholders with recommendations to replace/renovate the Pacific Community Park amenities.

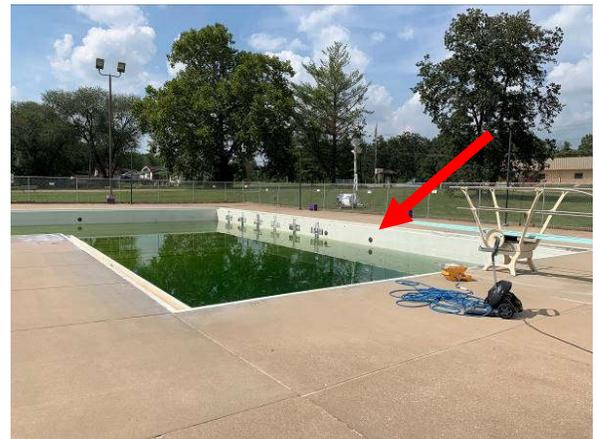
- ✓ **OBSERVATION:** Based on discussions with the swim team manager who stated a survey was performed, the pool depth profile does comply with current ISPSC for 1-meter springboard diving but per deck depth markings observed, not FINA minimum rule for pool depths which governing bodies like USA Diving, NFSHS, NCAA and manufacturer of current diving board follow. An additional 1-meter springboard was desired by the swim team manager.

- ✓ **OBSERVATION:** Underwater lights reported to be non-functional. Junction boxes not compliant with current Electric Code.

Photo #6 View of pool deep end and one-meter springboard diving stand and underwater lighting fixtures.

RECOMMENDATION: Meet FINA diving profile for springboard diving by removing and replacing pool floor to meet contours listed in their rule book or remove diving board. Provide an additional 1-meter springboard to meet aquatic programmatic request.

RECOMMENDATION: Replace underwater lights, niches, wiring and junction boxes.

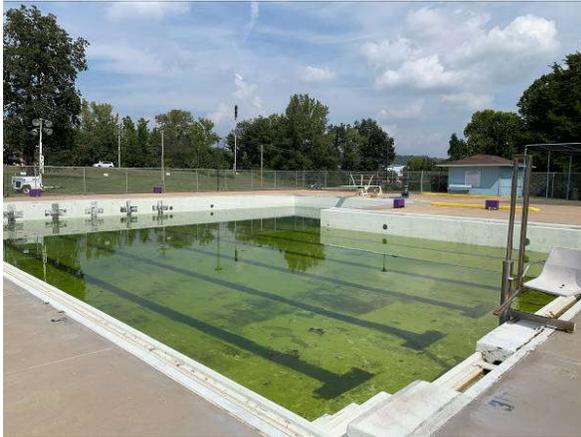
- ✓ **OBSERVATION:** Primary means of Americans with Disability Act Accessibility Guidelines observed (ADA) with a fixed lift at the shallow end of pool. The pool is greater than 300-lineal feet and requires two means of access, primary and secondary.
RECOMMENDATION: Confirm operation of fixed lift. Install railings at stair entry with 24-inch separation to meet secondary means of ADA access.

Photo #7 View of pool shallow end and ADA access lift.

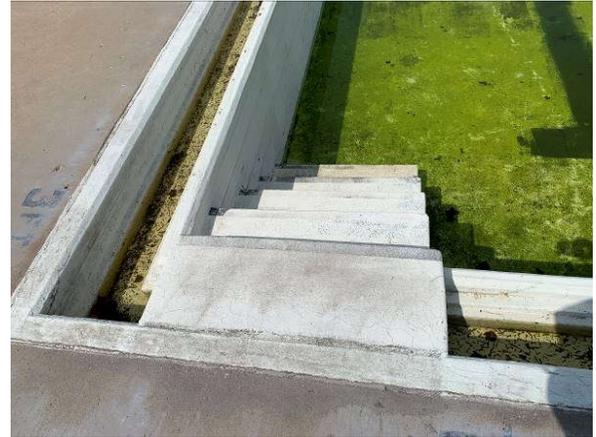
- ✓ **OBSERVATION:** Sections of pool gutter have been reported to be replaced over the past several years and concrete was reported to be soft and crumbled during previous demo and repairs.
RECOMMENDATION: Coring of the pool shell (floor) and Windsor Pin testing of pool floor and walls should be conducted and samples tested for compressive strength to determine integrity of concrete. If compressive strength of samples is below 3,000-psi, then we recommend replacement of the entire pool shell.

Photo #8 View of concrete gutter trough and stair entry.

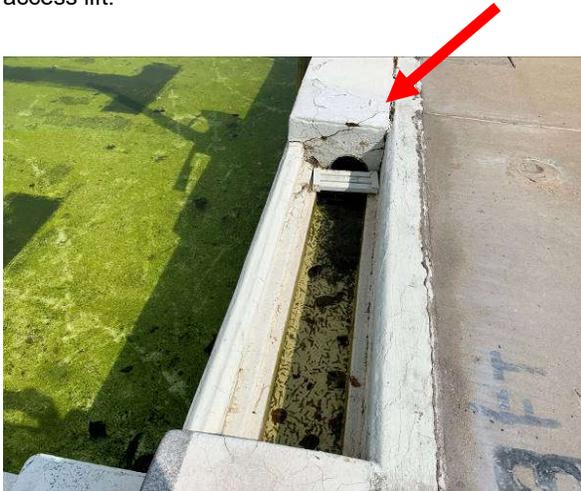
- ✓ **OBSERVATION:** Expansion joint sealant at pool gutter and deck interface observed to be worn.

Photo #9 View of cracked concrete at gutter and deck to wall joint.

RECOMMENDATION: Replace expansion joint sealant.

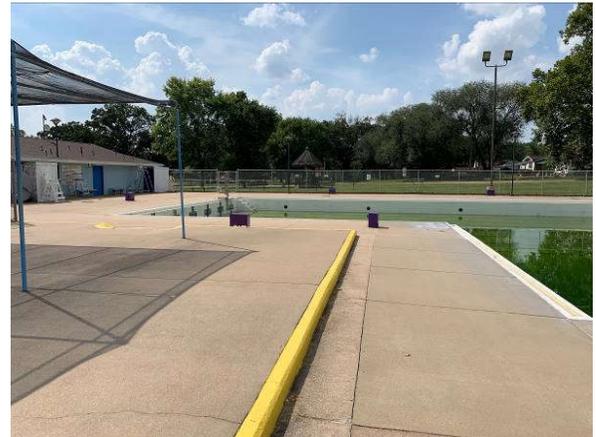
- ✓ **OBSERVATION:** Pool deck slopes toward pool which is non-compliant with current ISPSC. Cracking observed in several locations around the deck. Minimal differential settlement observed between pool wall and deck. Anchors for fixed lifeguard stations that have been replaced sit proud of deck creating a toe stubbing condition.
RECOMMENDATION: Demo and replace pool deck with appropriate slope to new drain system / grade or demo concrete pool gutter and install a stainless-steel gutter with integral deck drain system. If deck remains, repair deck cracks and remove fixed guard station anchors.

Photo #10 View pool deck sloping toward pool looking west.

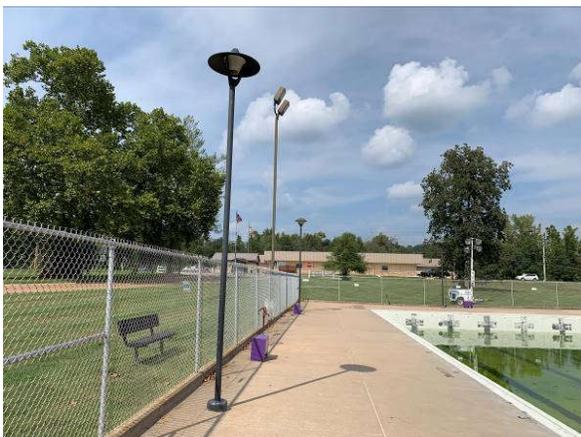
Photo #11 View pool deck sloping toward pool looking north and site lighting fixtures.

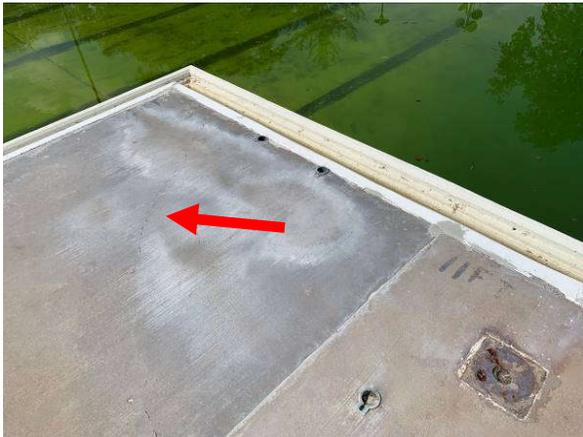
Photo #15 View of cracked deck and abandoned lifeguard chair anchors.

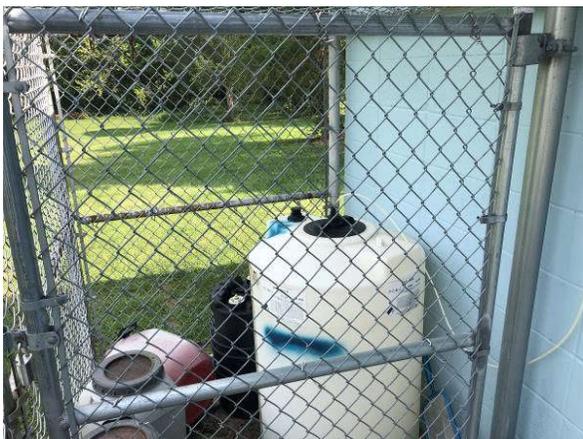
- ✓ **OBSERVATION:** No signage provided on pool chlorine and muriatic acid storage tanks and eyewash station or gloves or goggles not observed.
RECOMMENDATION: Provide signage, eyewash station, gloves and goggles.

Photo #17 View of pool water muriatic acid storage tank and enclosed area.

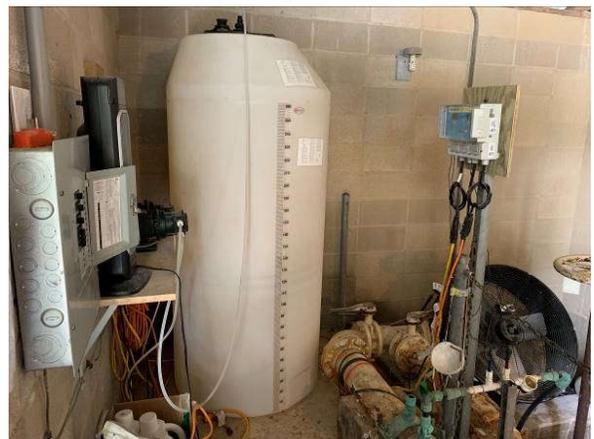
- ✓ **OBSERVATION:** Pool water liquid chlorine and muriatic acid feeders and storage tanks observed to be in fair to good condition. Pool water chemistry controller observed to be installed in 2017 and in good condition.
RECOMMENDATION: Salvage pool water chemical feeders, storage tanks and water chemistry controller.

Photo #18 View of pool water liquid chlorine storage tank.

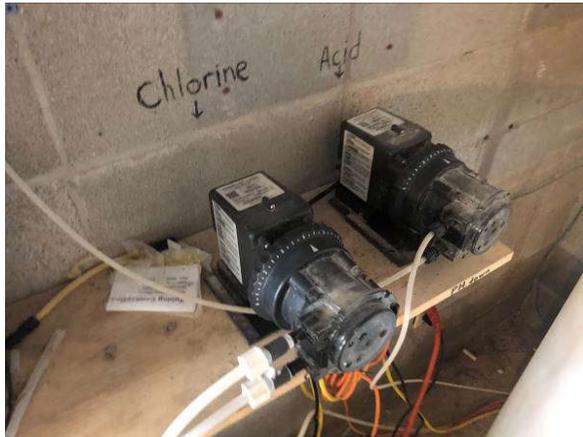
Photo #19 View of chlorine and acid feed pumps.

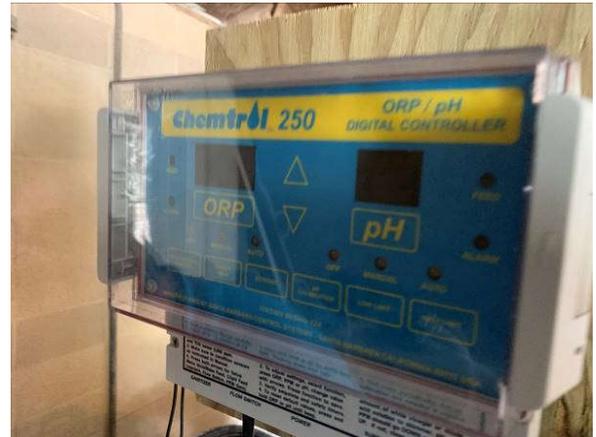
Photo #20 View of pool water chemistry controller.

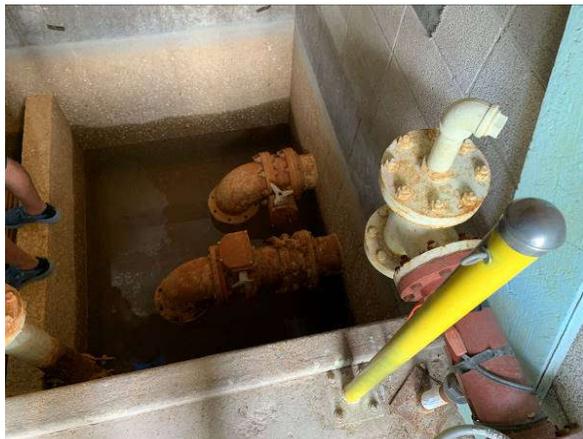
- ✓ **OBSERVATION:** The approximately 3,330-gallon pool filter / balance tank is undersized to meet current code requirement of approximately 5,400-gallons. Gutter capacity observed to be approximately 625-gallons.

- ✓ **OBSERVATION:** Pool main drain and gutter piping (6-in cast iron) undersized to meet current Code requirements and exposed pipe observed to be corroded.

Photo #21 View of pool surge tank and cast-iron piping from main drains and gutter.

RECOMMENDATION: Install balance tank sized to meet current code requirement.

RECOMMENDATION: Replace piping from main drains and gutter header piping at pool sized to meet commonly accepted industry practices at 800-gpm.

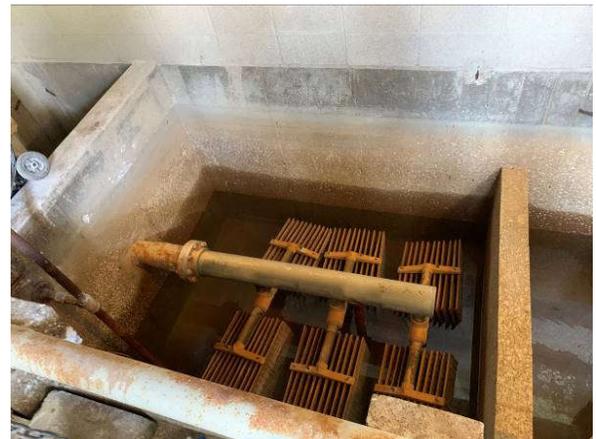
- ✓ **OBSERVATION:** Sixty-six DE filter sleeves providing 346.5 sq. ft. of filter area observed in the concrete filter tank. Filtration rate at 1.7-gpm/sq. ft meets current code but not commonly accepted industry practices at the 800-gpm flow rate.
RECOMMENDATION: Refurbish existing filter sleeves and piping for 2020 swim season and then provide new filter system meeting commonly accepted industry practices.

Photo #22 View of DE filter tank and sleeves.

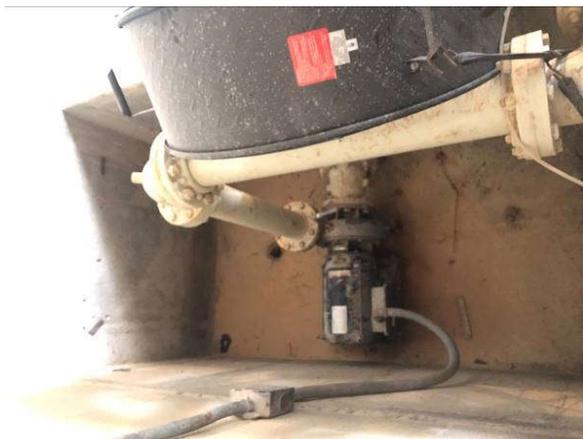
- ✓ **OBSERVATION:** Pool filtration pump (7.5-HP *Marathon* motor) undersized to meet design filtration rate at 8-hours. Existing pump reported to be non-functional and a new 7.5-HP pump has been purchased by the City but not yet installed.

Photo #23 View of pool filtration pump and piping adjacent to filter tank.

RECOMMENDATION: Install 7.5-HP pump for 2020 season and afterwards, install pool filtration pump that meets commonly accepted industry practices for turnover rate (6-hour turnover rate requires 800-gpm pump flow rate).

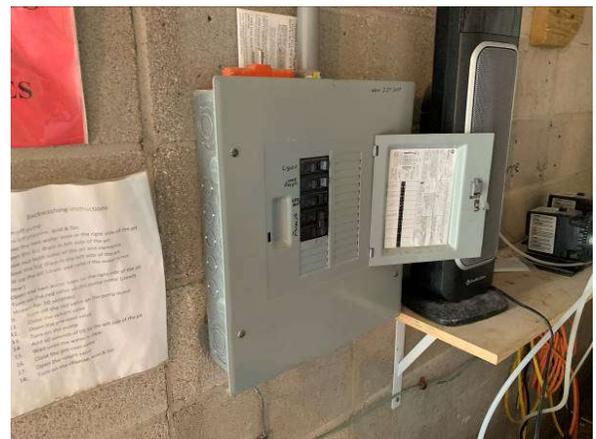
- ✓ **OBSERVATION:** Electrical circuit panel for pool equipment room observed to be replaced in 2017.
RECOMMENDATION: Confirm electrical service is sufficient for recommended pool renovations.

Photo #24 View of pool equipment electrical circuit panel.
